TYNDALL AFB BOMB DAMAGE REPAIR FIELD TEST, DOCUMENTATION AND ANALYSIS

Lawrence D. Hokanson, Capt, USAF
Air Force Weapons Laboratory

October 1975

Final Report

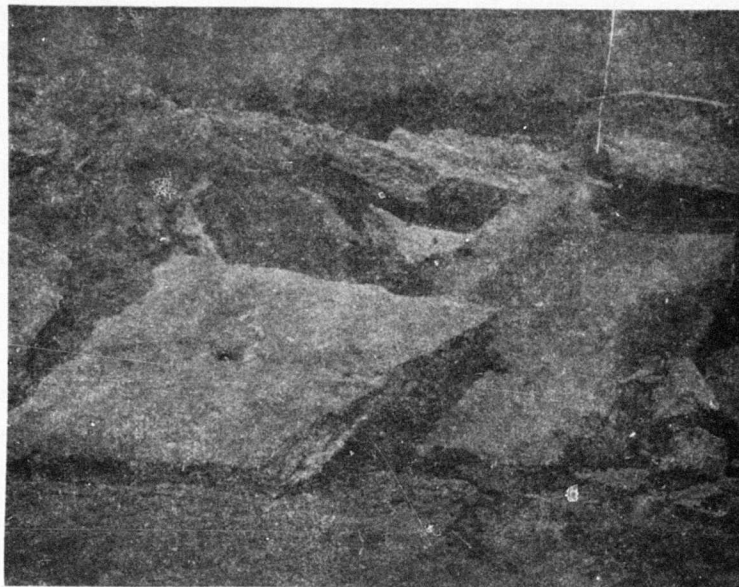
In Test 1-1 a large amount of time was expended in removing broken concrete slabs from the crater area (figure 9) even though a shortage of backfill material existed. This material would have made excellent backfill; however, AFM 93-2 provides no guidance for determining suitability. The solution to this lies both in training of potential BDR OICs and NCOICs and in providing more guidance in AFM 93.2.

Figure 9. Test 1-1, Broken Slabs Removed from AM-2 Air Field Patch Assembly Area

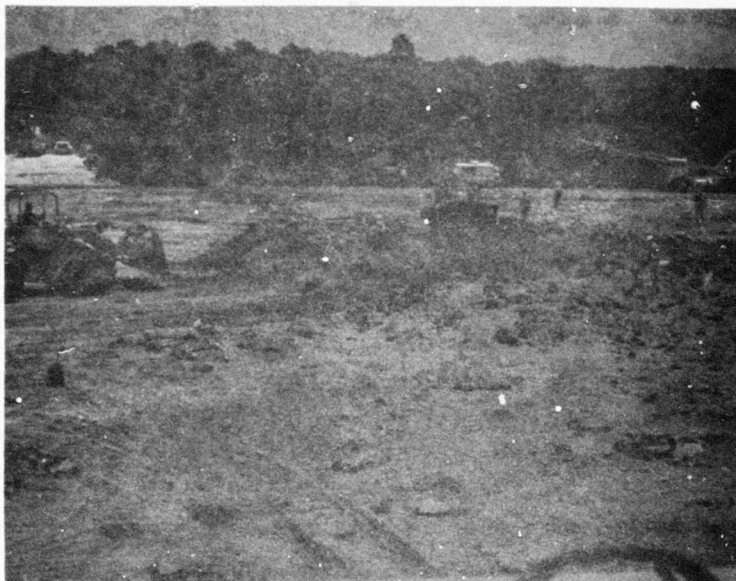
Figure 11. Test 1-1, AC 645 Loader Attempting to Push Debris Directly into Crater

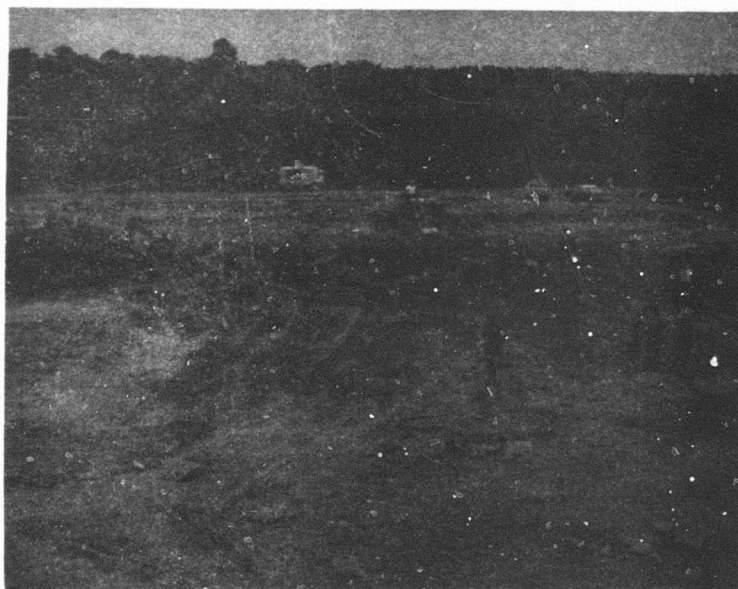
Figure 14. Test 1-1, Comparative Work Done by TD 20, Right Side, and Three AC 645's, Left Side, in Equal Period. Note Minimum work accomplished by 645's since repair progress shown in figure 11.

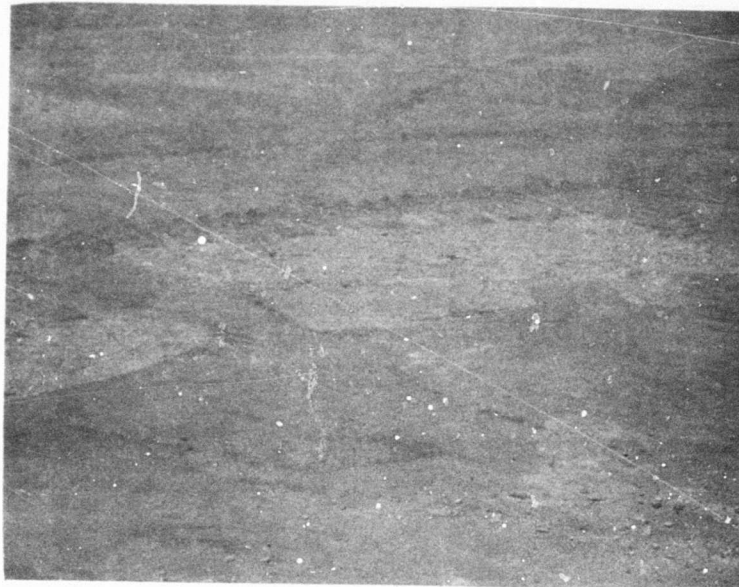
Figure 15. Test 1-1, Pavement Gouges Made by AC 645 Loaders with Four in One Buckets

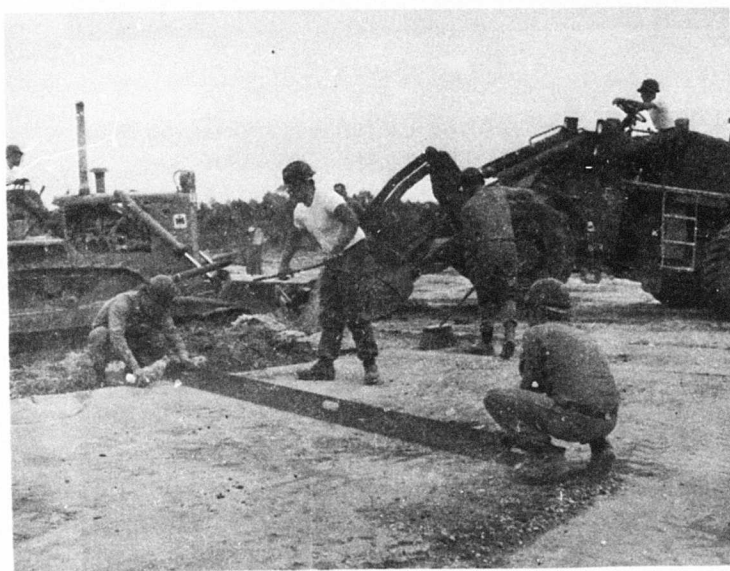
This was the most time consuming and complex problem faced in this exercise. The broken and badly upheaved concrete was readily and easily pushed into the crater early in the repair by the dozer. However, once the obviously damaged material was pushed in, the equipment operators did not recognize the further upheaved areas that required removal. This problem was aggravated by the inability of the OIC to check for upheaval until the pavement had been thoroughly cleared of ejecta, and this came late in the backfill process (1351, figure 16).

Figure 16. Test 1-1, Identifying Subtly Upheaved Pavement with Specified Straight Edge

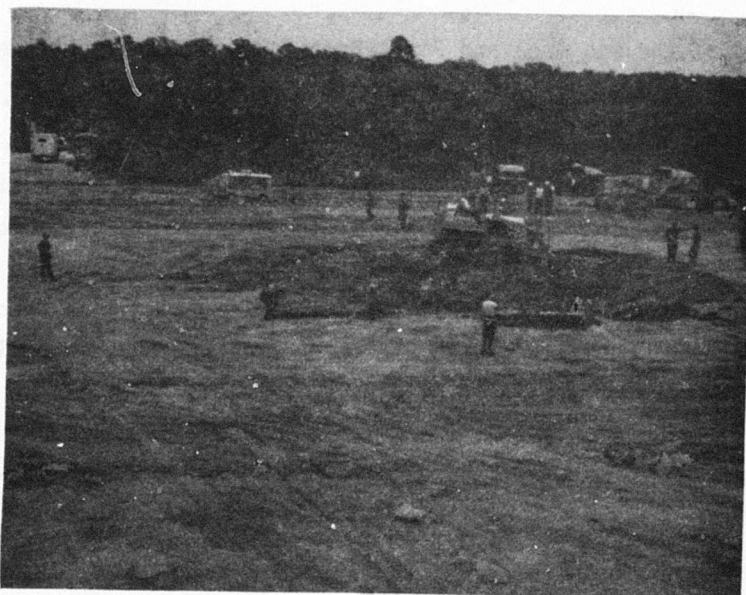
Once the pavement to be removed was identified, a time-consuming process of lifting the pavement out with a dozer or loader blade (figure 17) and then loading the debris into a loader bucket began (figure 18). The equipment in the package is not suitable for this use. Since the overlay of asphaltic concrete physically hides the joints in the pavement, it is extremely difficult to find a point at which the concrete can be broken for removal.

Figure 17. Test 1-1, TD 20 Lifting and Breaking Free Large Upheaved Pavement Sections

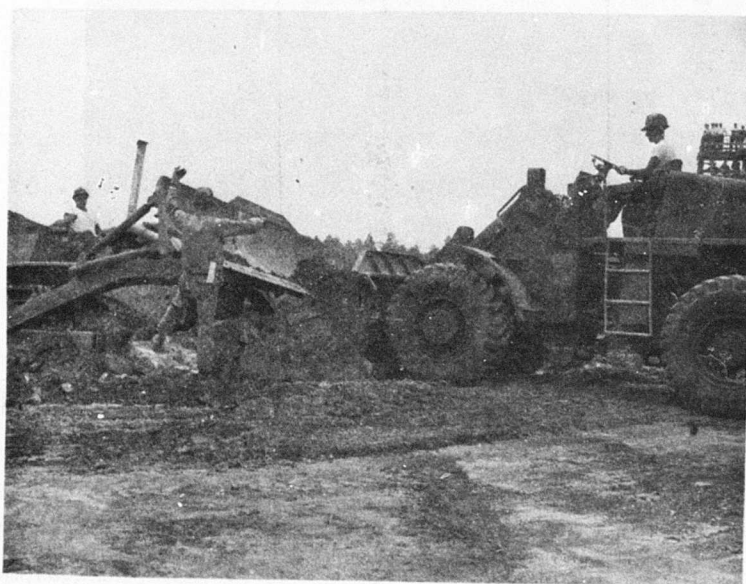
Figure 18. Test 1-1, TD 20 Inside Crater Aiding AC 645 in Removing Large Upheaved Pavement Sections

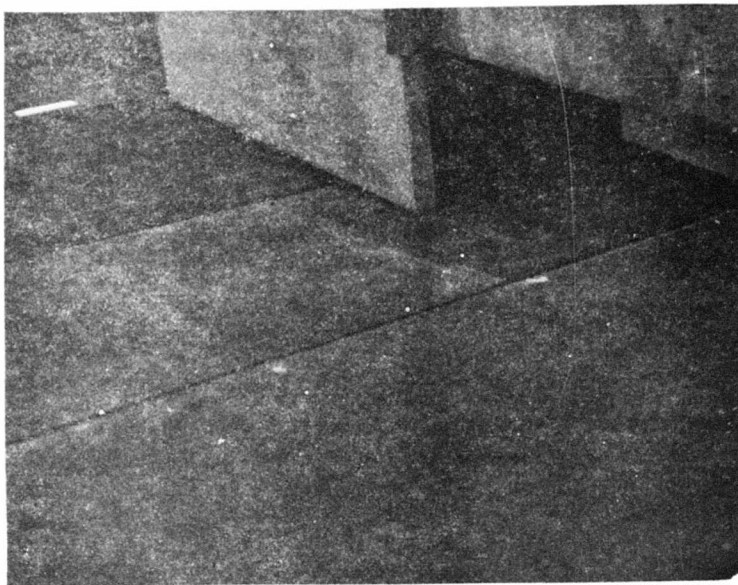
The deflection recorded does not represent the maximum in the case of line C, where each point was loaded as the deflection was measured. Rotation of the sections of mat relative to each other caused an extreme concentrated load along the dedge of the mat panels abutting the joint. This deflection was extreme enough that a part of the load cart had to be removed to complete the testing (figure 30). The poor compaction of the base course, described above, is believed to be the cause of this problem.

Figure 30. Test 1-1, F-4 Load Cart Hung Up on Excessive Deflection in AM-2 Airfield Patch

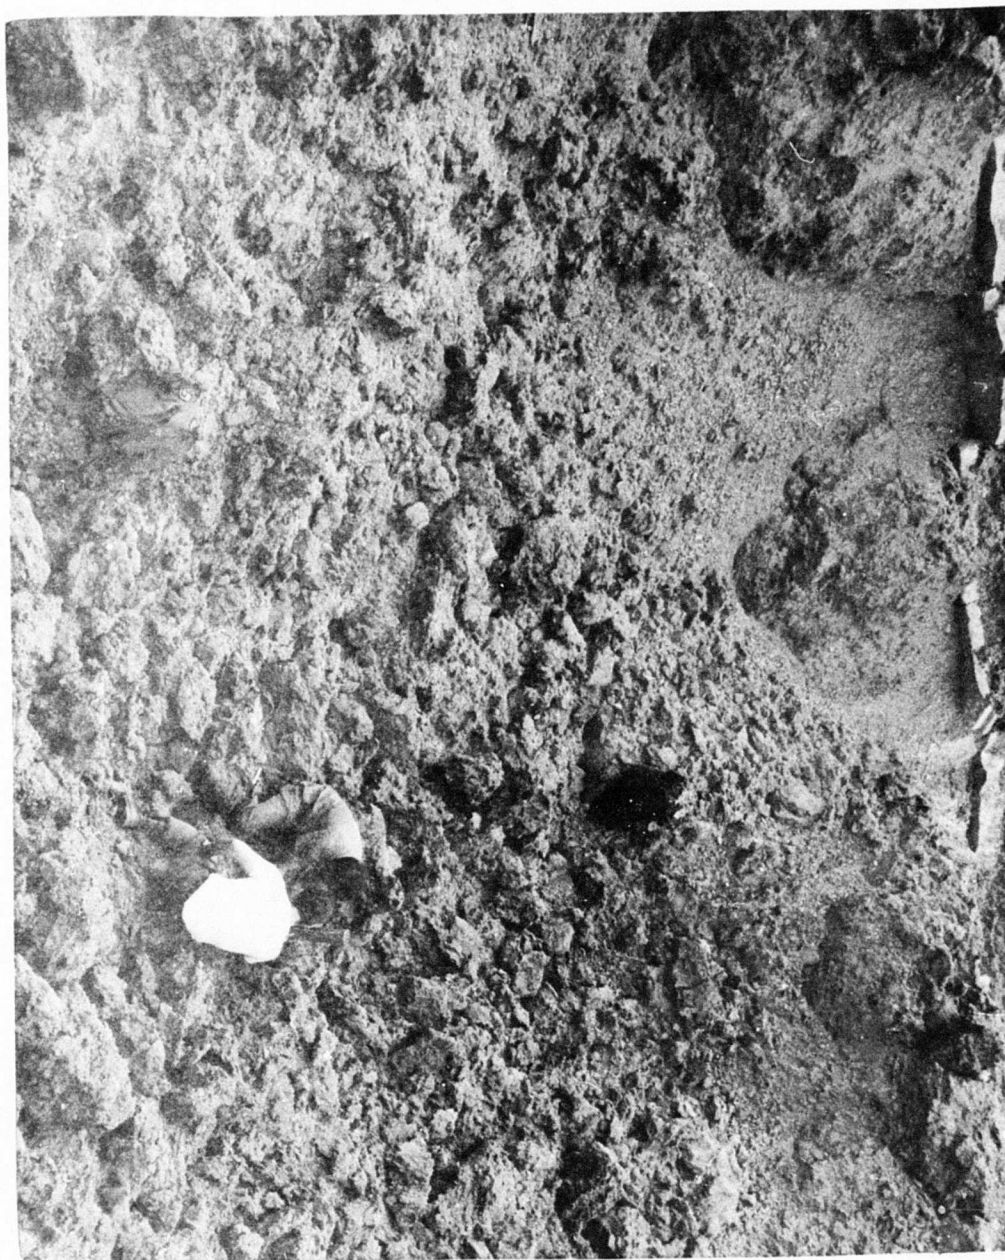
Figure 44. Test 1-2, Distorted and Sheared Crater Wall and Floor Material

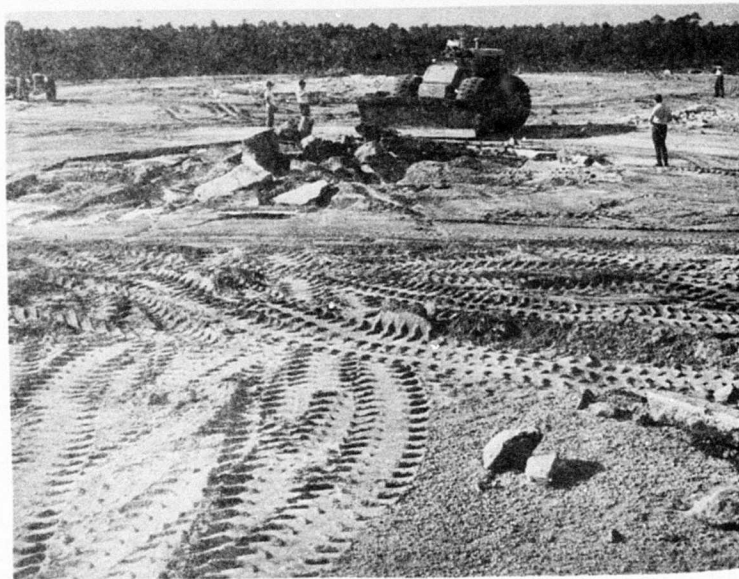
Because of the problem encountered with the use of the 280 RT noted below, the procedure took longer than had been expected. One factor causing excessive time was the over filling of the crater (figure 61) with debris and the tardy switch from working outside the crater to working inside. It was originally felt that the 380 RT could handle the entire job from outside the crater. In addition, if a machine capable of uplifting the pavement had been moved inside at an earlier time, (figure 62) the elapsed time would have been further reduced. In general, the procedure worked well as witnesses by table 12, a schedule of events during the actual test. Had the crater not been overfilled with debris the use of the TD 20 tractor would have been avoided. This equipment package and procedure was far superior to that exercised in Test 1-1, and is the basis of the proposed repair procedure and equipment package suggested later.

Figure 61. Test 1-3, Overfilling of Crater with Debris

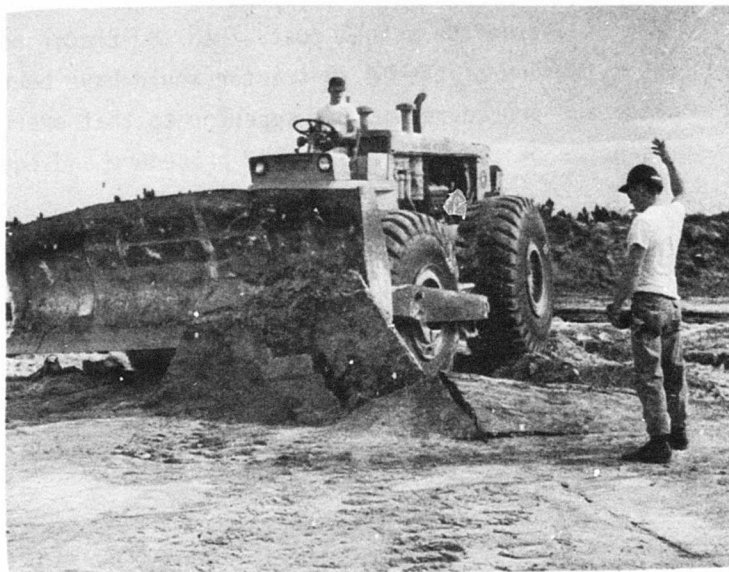
Figure 62. Test 1-3, 280 RT Lifting Upheaved Pavement from Inside the Repair

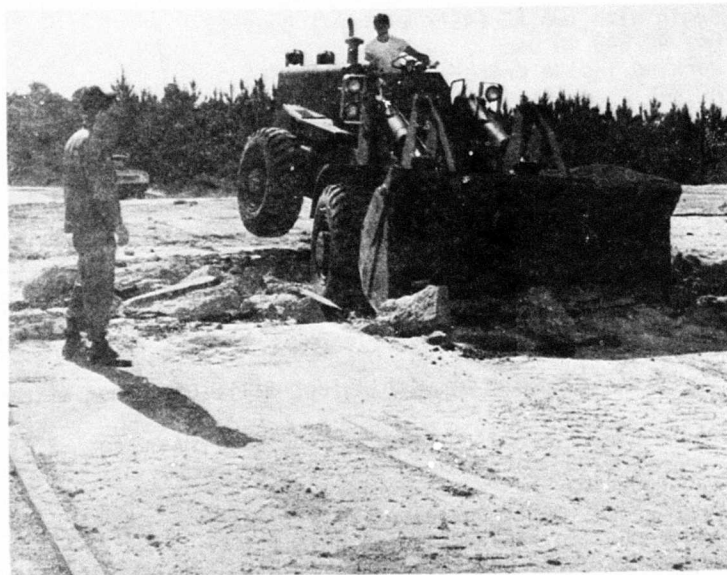
Figure 65. Test 1-4 NE, AC 645 Removing Upheaved Pavement from Inside Crater

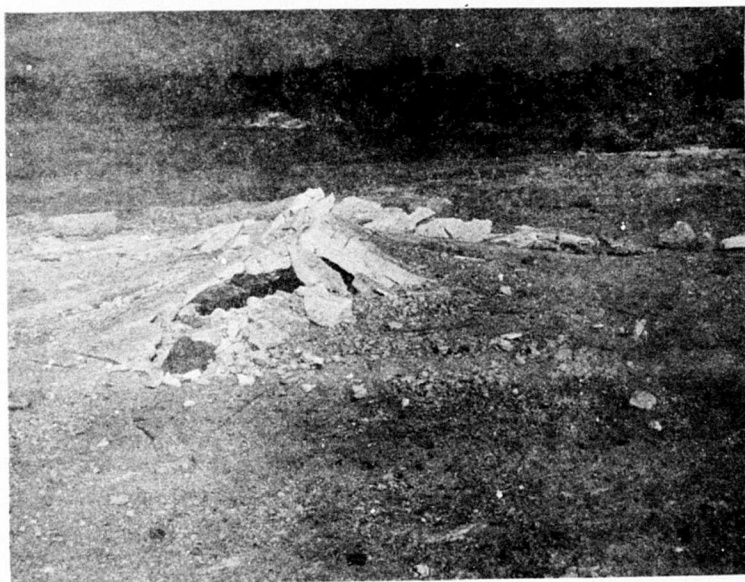
Expansion and contraction phenomena in the mass of regulated-set led to failure within weeks (figure 70). This is discussed in section VIII.

Figure 70. Test 1-4 NW, Failure of Regulated-set Cement Cap

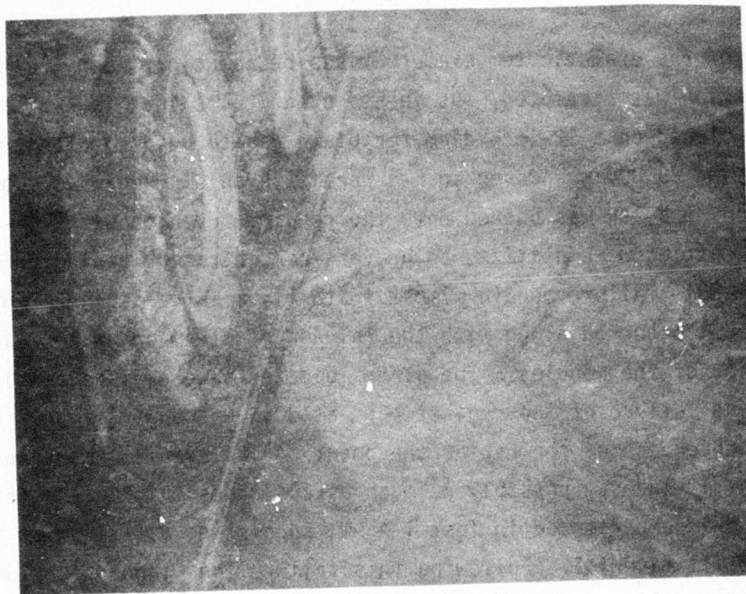
Figure 88. Test 2-1, AM-2 Matting Used to Support Load Trailer,
Also Shown are Concentric Cracks

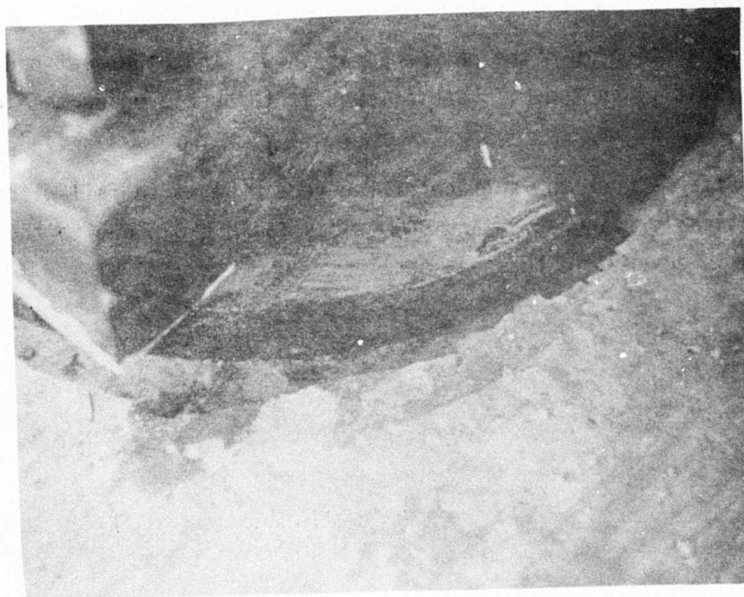
Figure 89. Test 2-1, Punching Failure of Reg-set Cap under Load Plate

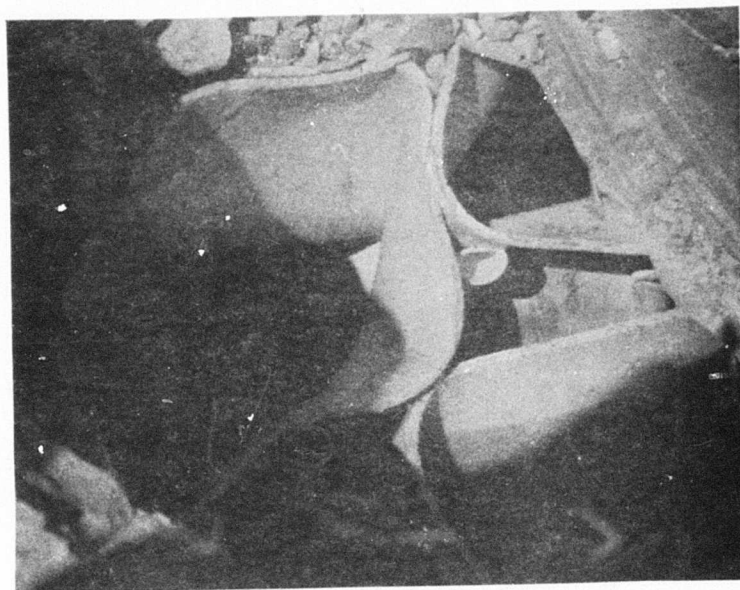
Figure 92. Test 2-1, Buckled PVC Module Elements
Beneath Failure in Figure 91

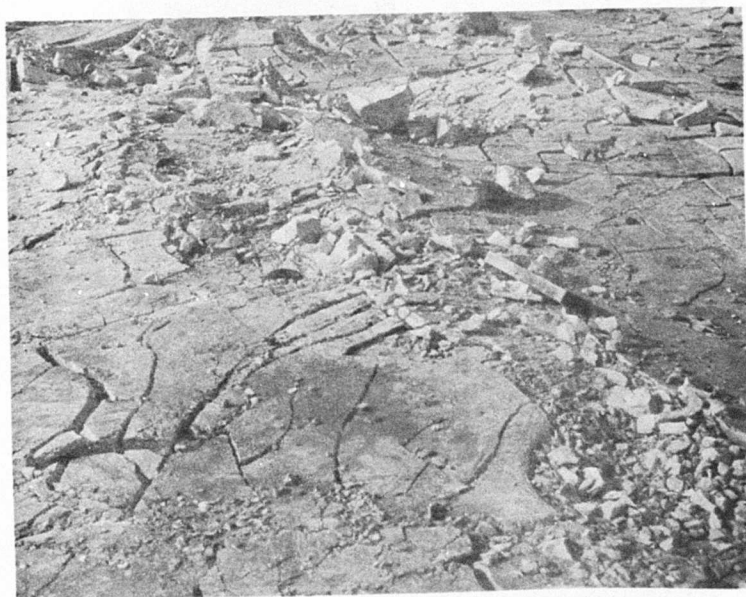
Figure 93. Test 2-1, No Load Deterioration of Reg-set Surface

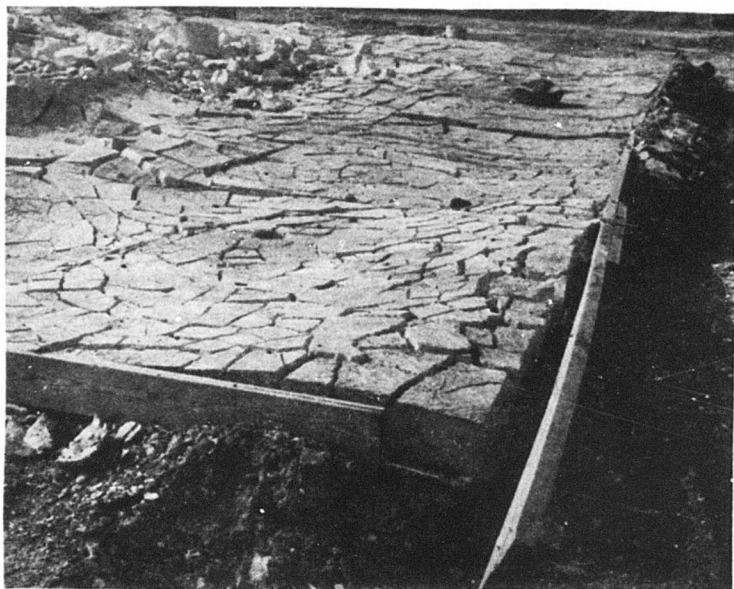
Figure 94. Test 2-1, Evidence of Expansion in Reg-set Surface

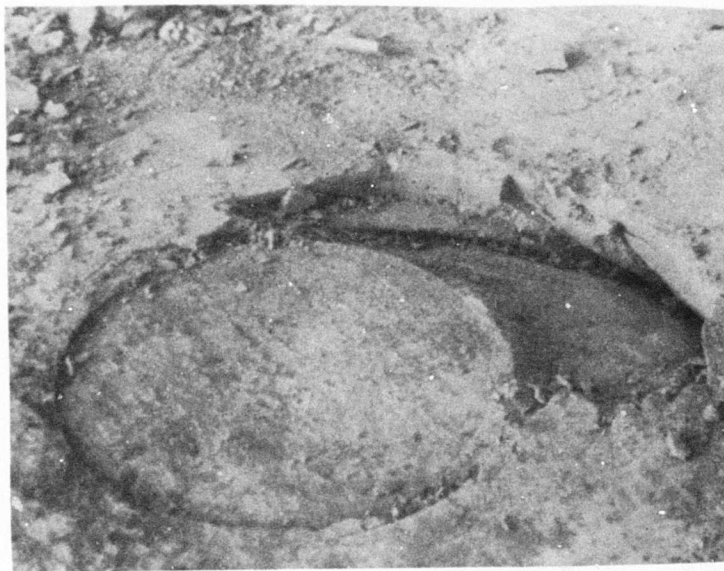
Figure 110. Punching Failure on Reg-set Cap Test 1-4 NW

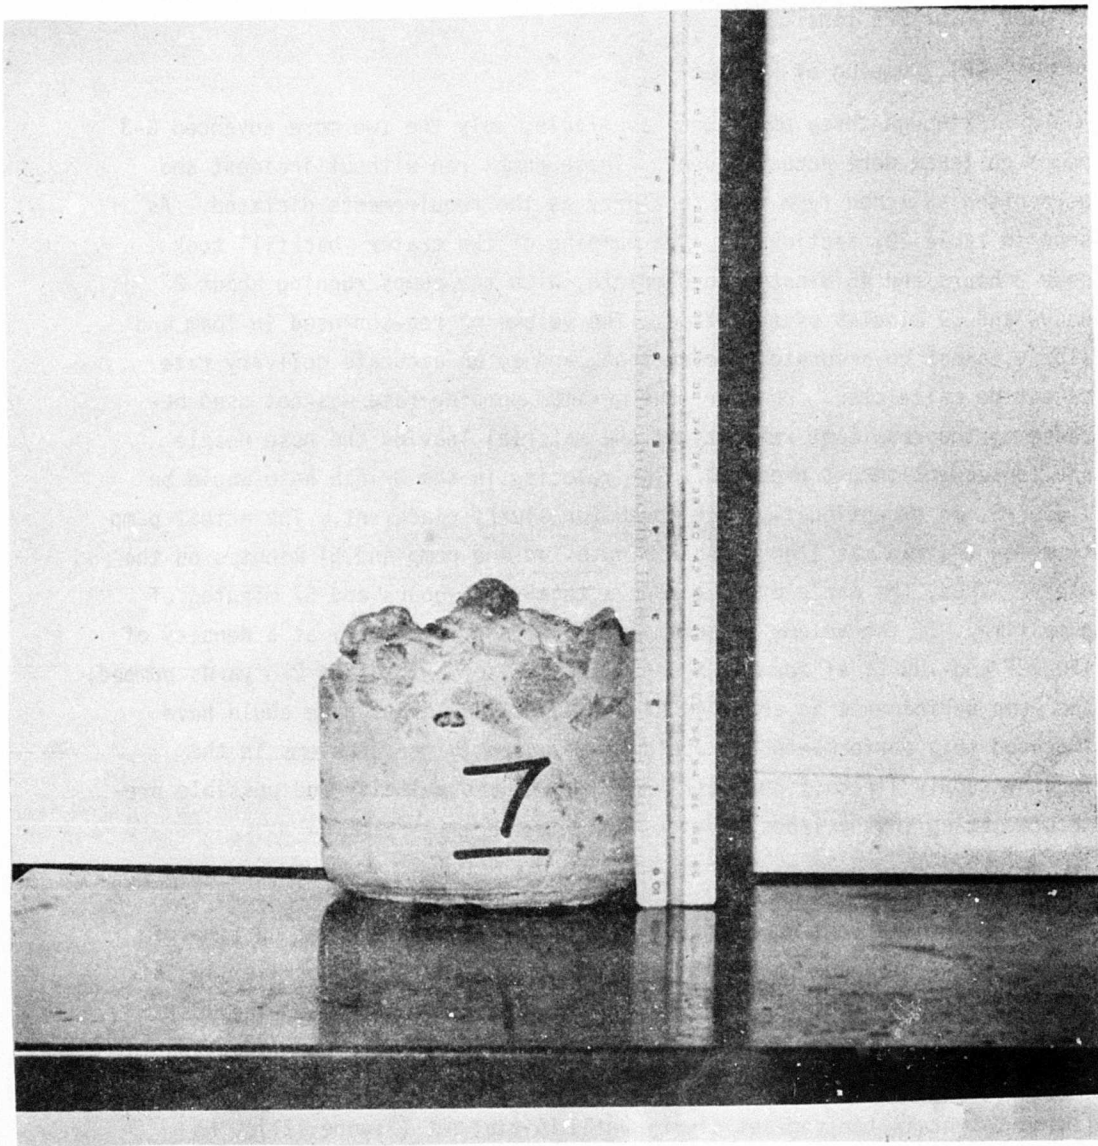
Figure 116. Core Sample Illustrating Slurry Cut Off by Fines

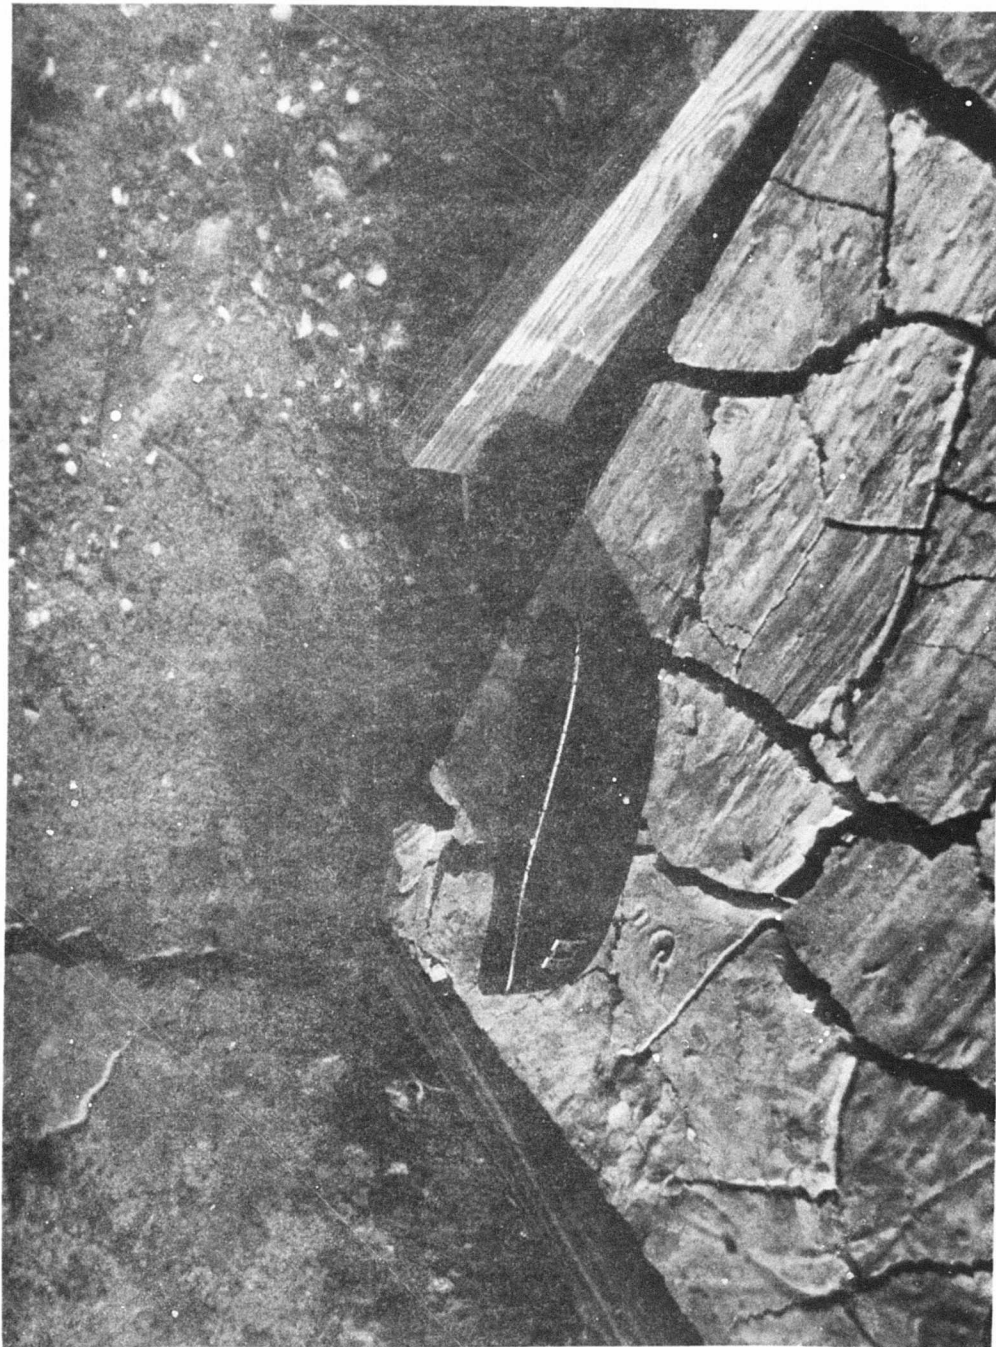
Figure 122. Evidence of Extreme Expansion, Deteriorated Cap, Test 2-1

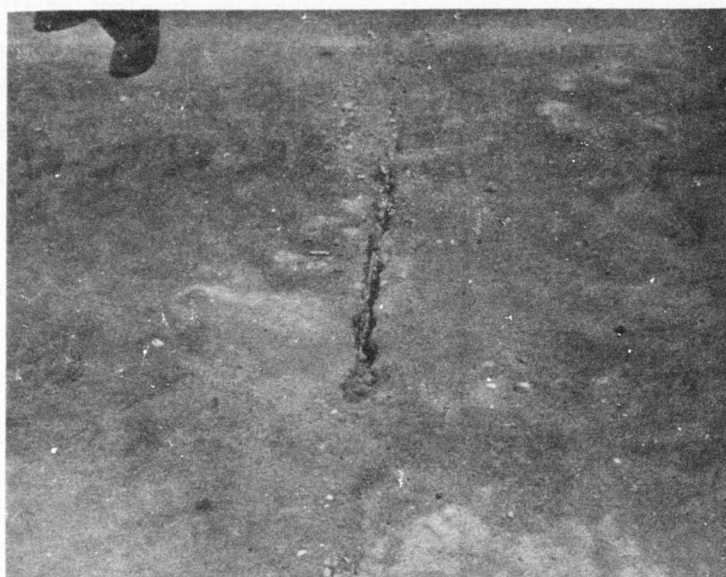
Figure 126. Pavement Cracking Outside Zone
of Upheaval, Test 1-1
